Photographic Documentation

Name of Facility: US Ecology Site-B

Inspection Date: Monday, November 26, 2018

Purpose of Inspection: November 17 Incident

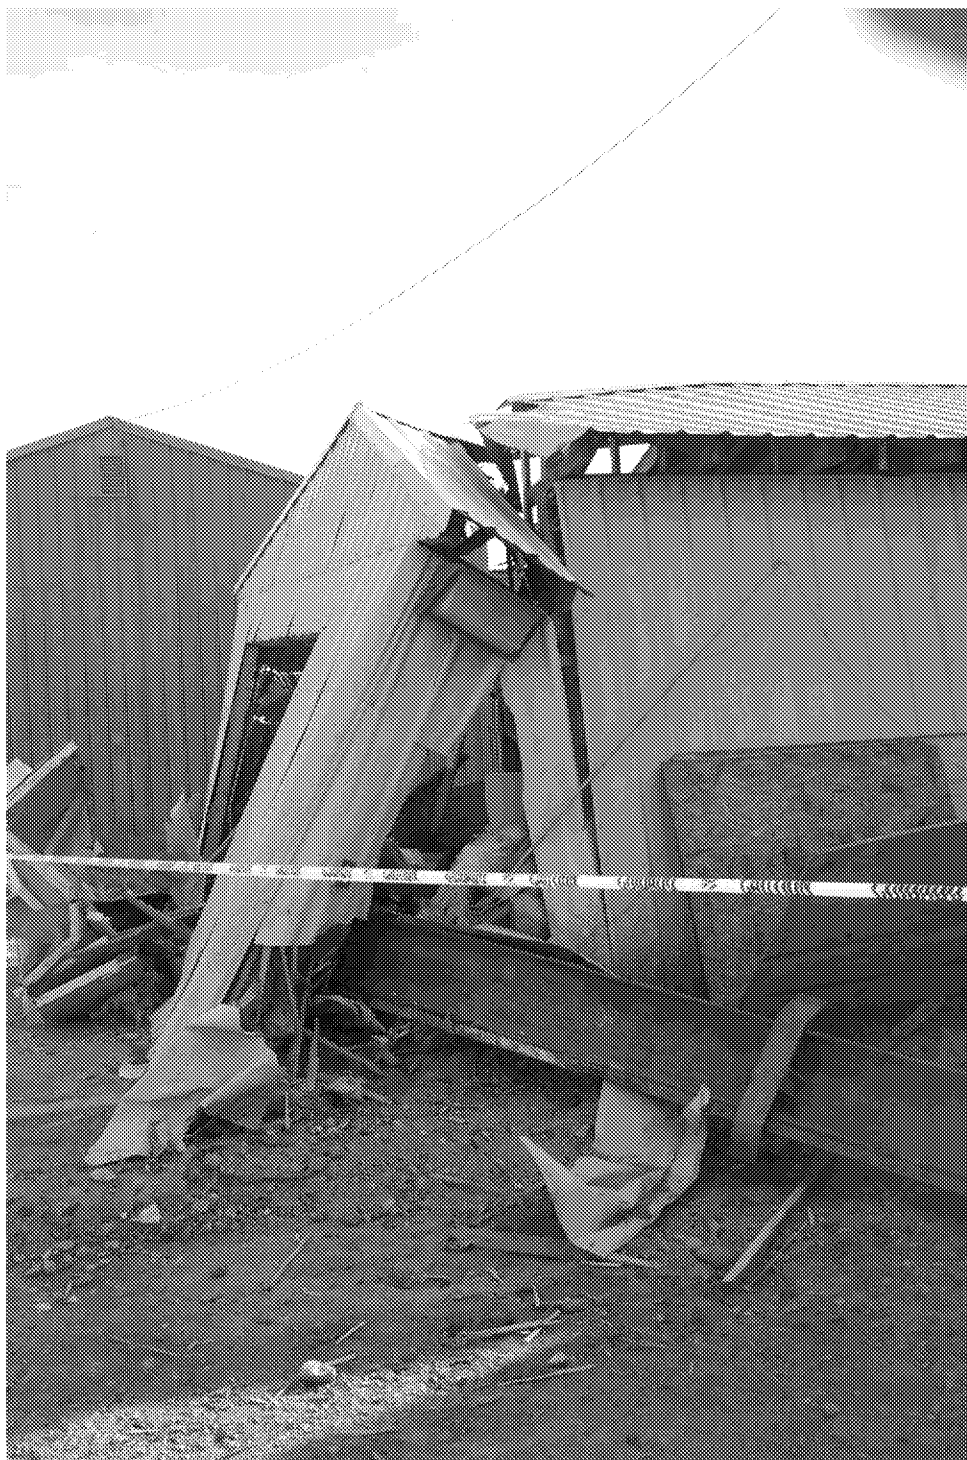
Photograph DCP-7696: Structural I-beam from Containment Building approximately 450 ft to the South completely sliced building located on North Side of Pad 7, looking East.

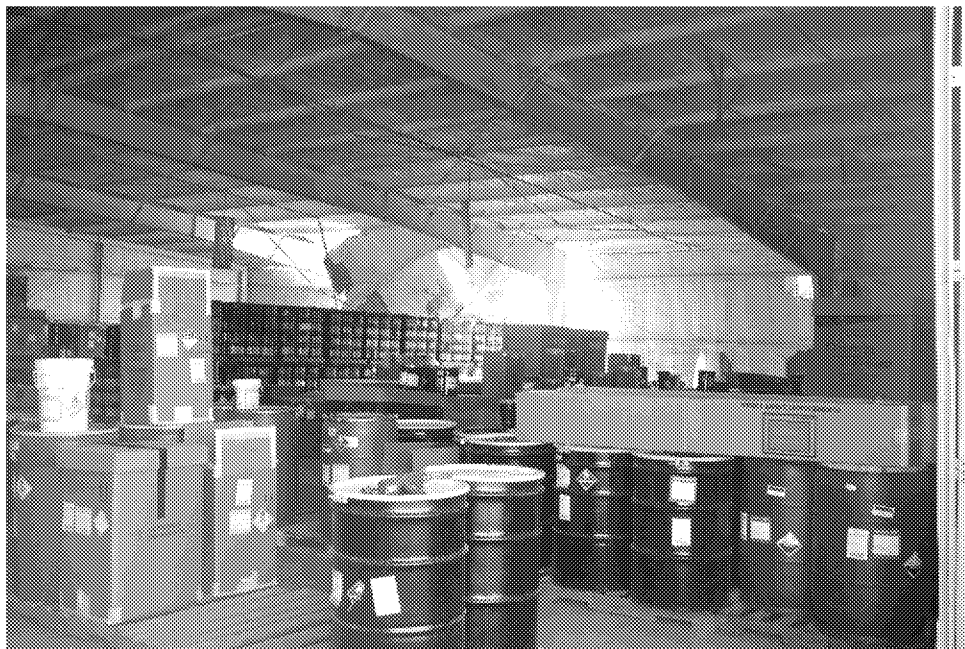
Photograph DCP-7697: Inside Pad 7 looking at South Wall.

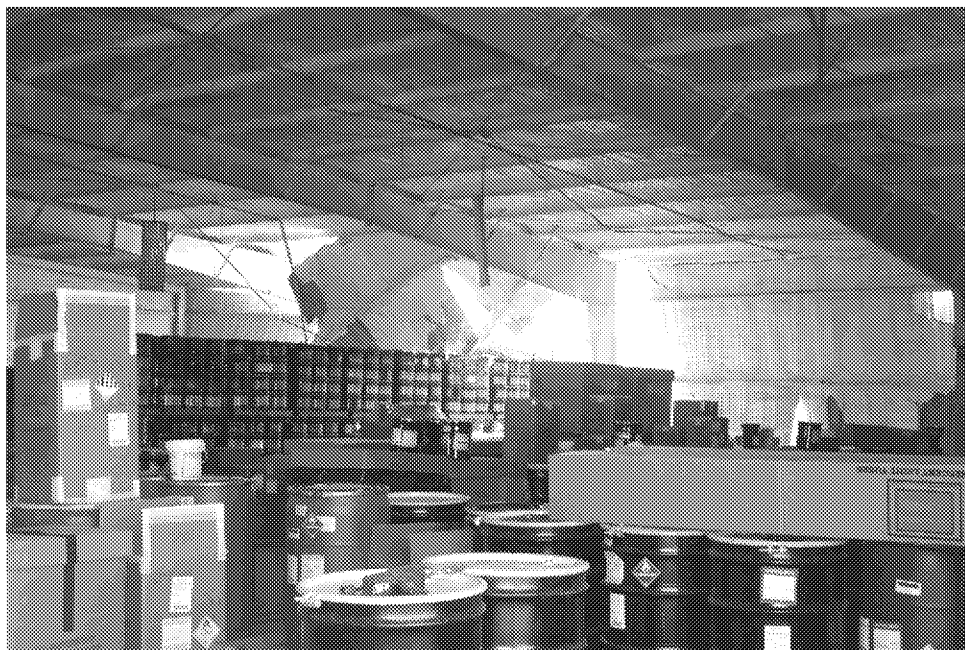
Photograph DCP-7698: Inside Pad 7 looking at South Wall.

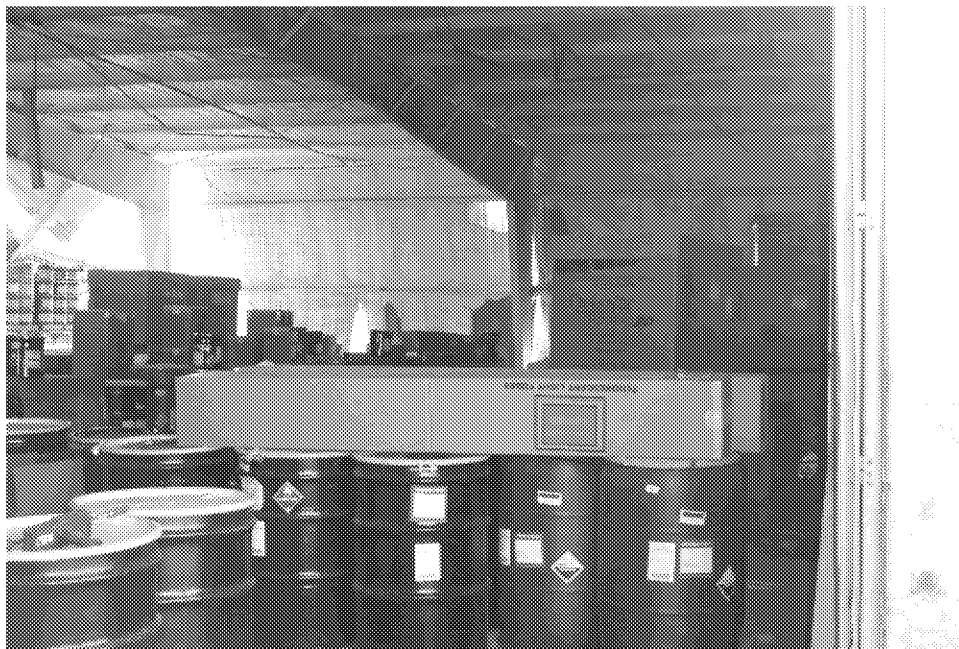
Photograph DCP-7699: Inside Pad 7 looking at South wall.

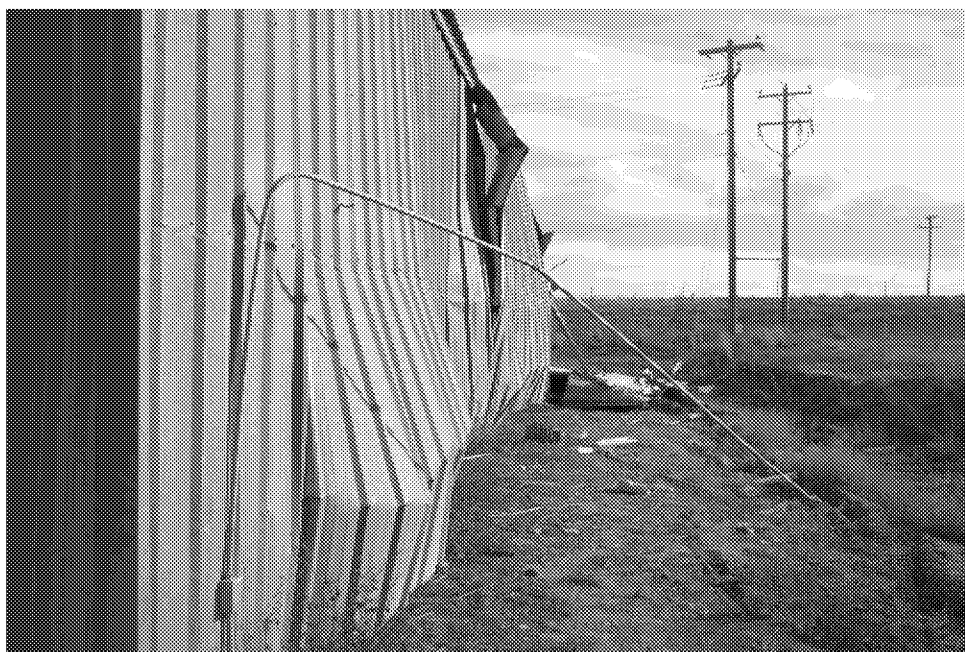
Photograph DCP-7700: Looking East along South wall of Pad 7.

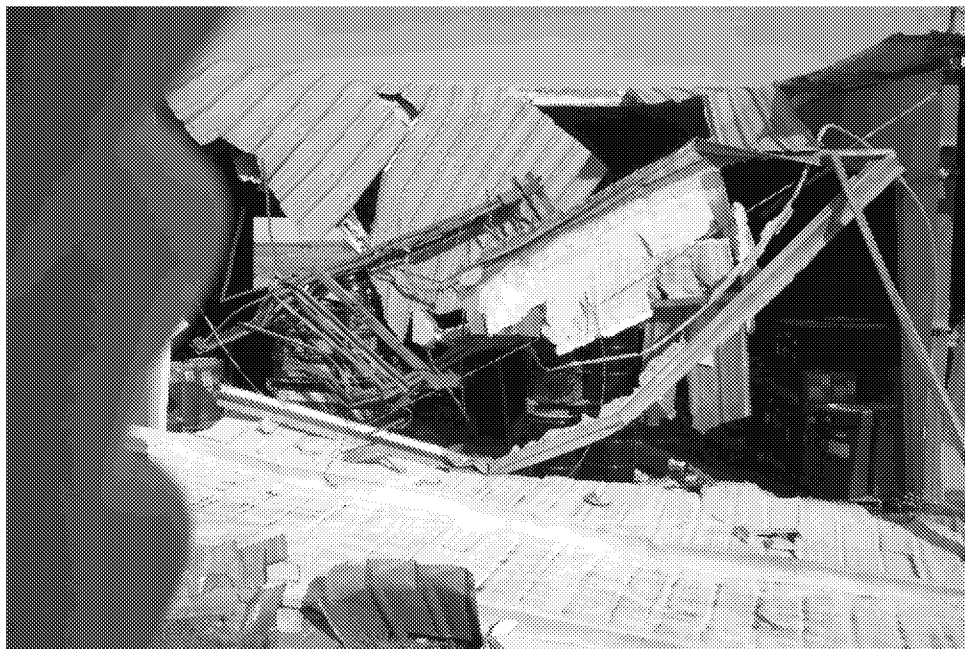
Photograph DCP-7701: Roof truss section from Containment building, approximately 350 ft to the South, damaged roof and south wall sections of Pad 7, looking North.

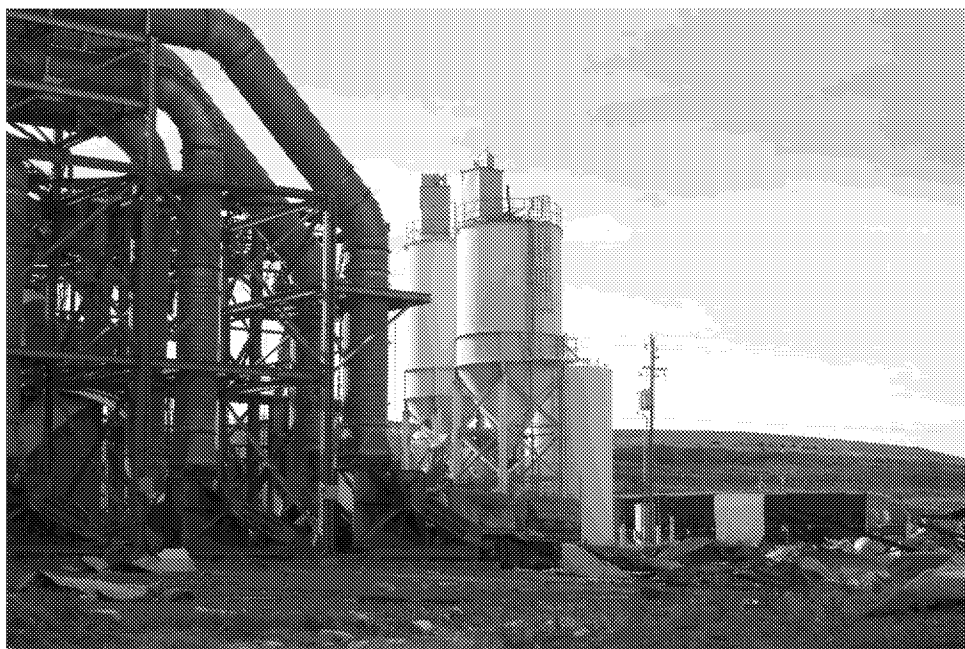
Photograph DCP-7702: Reagent silos to the West of Containment building, note damage to access ladder guard, severed lines, next to access ladder and damage to square structure on top of silo, looking Southwest.

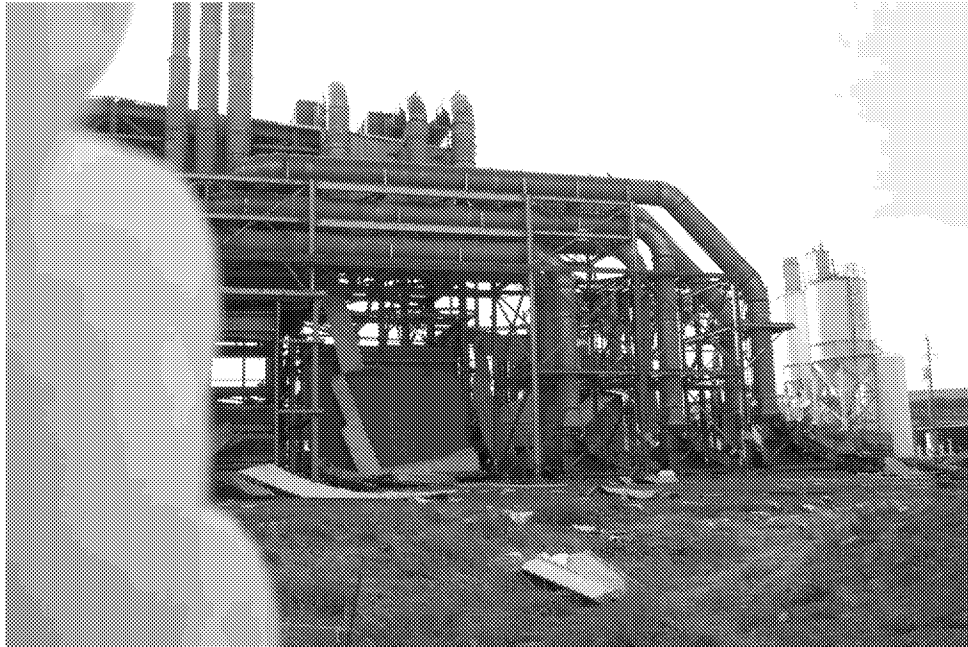
Photograph DCP-7703: North side of Containment building, note ductwork all appears to be intact, looking Southwest. Fingers on left side of Photo.

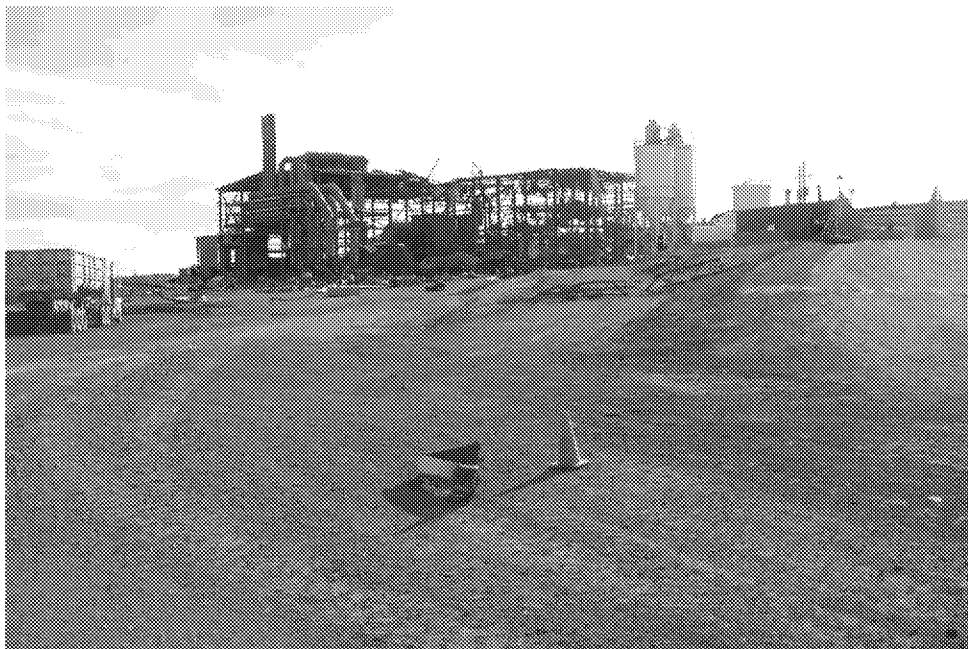
Photograph DCP-7704: Structural metal several feet long in foreground approximately 400 feet from Containment building and roof truss section further back approximately 300 feet from building. Other similar sized pieces still further away from building, looking Southeast.
